Re: PCB Spill

Re: Follow up sampling from previous PCB Fluid
Spill in the Plant Main Substation

Re: Remediation of PCB spill area.

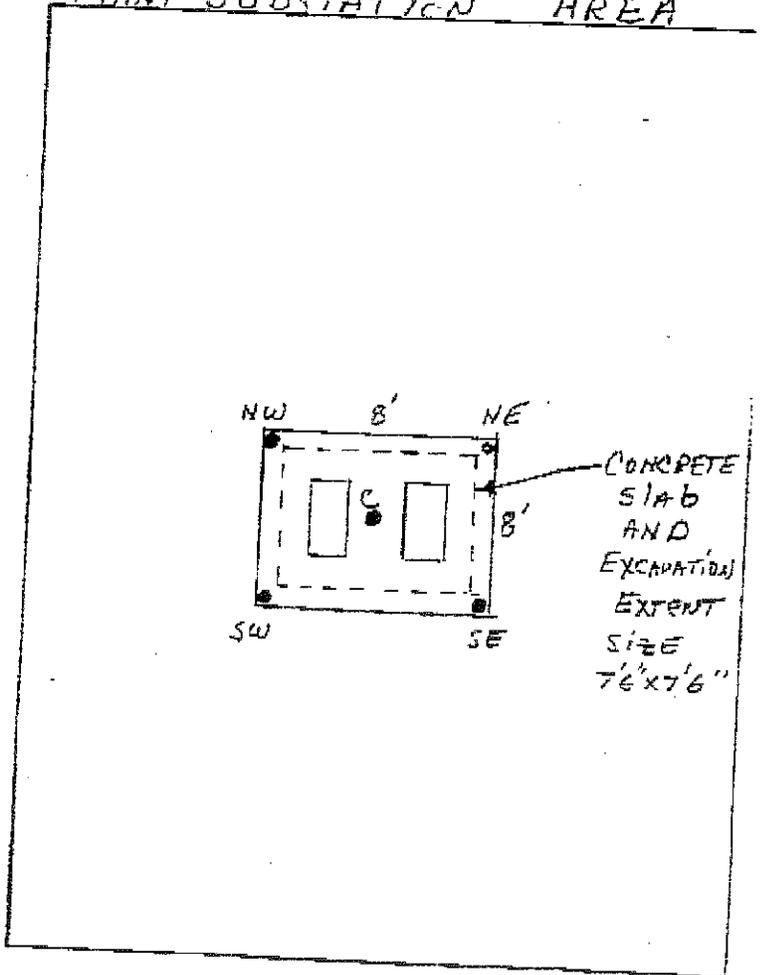
PLANT SUBSTATION AREA

On May 4, 1993, Cousins personnel arrived at the spill site for the specific purpose of collecting samples to quantify the extent of the contamination caused by the spill. This spill occurred underneath a small capacitor bank within the plant substation. The area under the capacitor bank was sectioned off for the purpose of establishing a sampling grid. A schematic of the spill area and the collection points of the samples is attached in Appendix A. Samples were taken at the corners of the four boxes at depth intervals of surface, one foot, and two foot. A sample was taken directly beneath the capacitor bank at the depth of one foot. The capacitor bank supports are resting on a concrete slab at a depth of one foot below the surface. The slab is represented in the schematic as the dotted line.

The results of the analysis are enclosed in Appendix B. From the results of the analysis the area to be remediated was determined. On June 24, 1993, Cousins personnel returned to the site to complete the remediation. The remediation consisted of excavating the contaminated soils beneath the capacitor bank from the surface to the top of the concrete support slab. The extent of the excavation is shown in the schematic in Appendix A. After the excavation, the slab was inspected for the presence of cracks. This inspection revealed that the slab did not have any cracks, thus there is no reason to believe that the contamination went any further. The excavation generated six drums of PCB contaminated waste which were properly labeled and staged for disposal. The maintenance staff at the site provided the clean backfill for the excavation.
